Title: Amendment to alleviate constraints on Corner Protection Plates and Header Extension Plates.

The objective: TB0-023 is to revise repair requirements, considering the latest container designs and prioritizing the preservation of original materials and coating systems whenever possible.

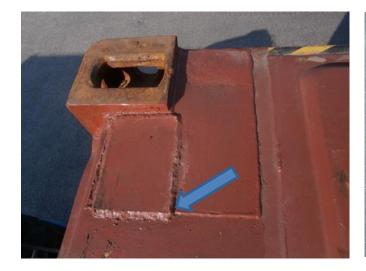
Non-conforming patch exceeds the original size of the Corner Protection Plate.

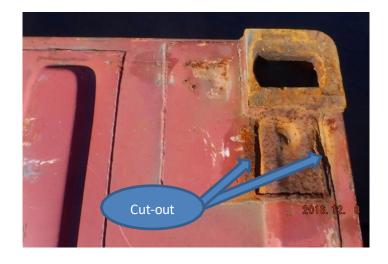
Non-conforming repair.

The section of the corner protection plate was cut-out but not restored.

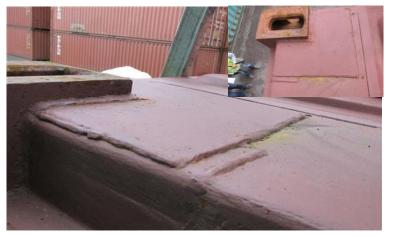
Proper replacement of the corner protection plate after installation of insert on the front header.

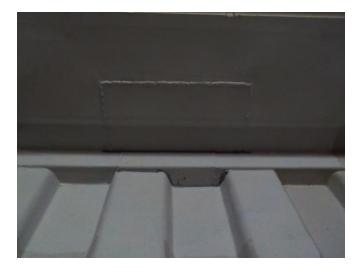
Proper insert to the header extension plate.

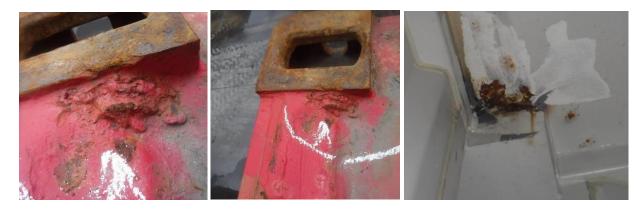
Non-conforming repair. The damaged area filled with weld without restoring original profile of the rear Header and corner protection plate.

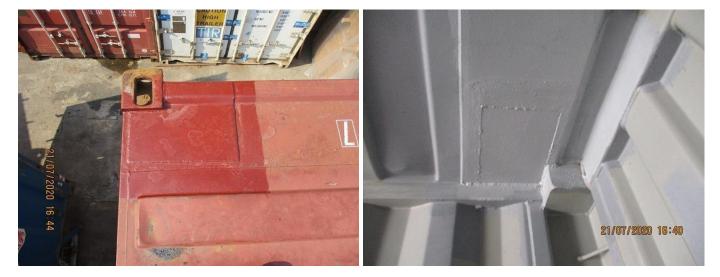
Proper replacement of the corner protection plate after installation of insert on the extension plate.

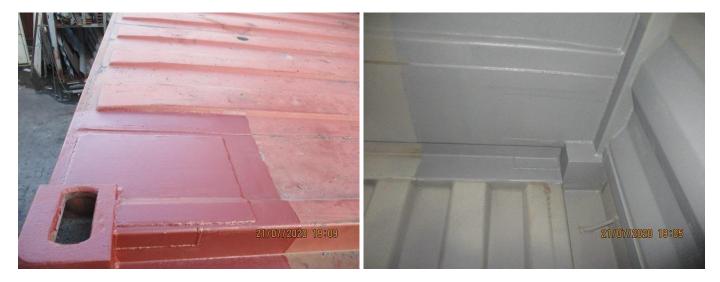
Proper replacement of the corner protection plate after installation of insert on the front header.

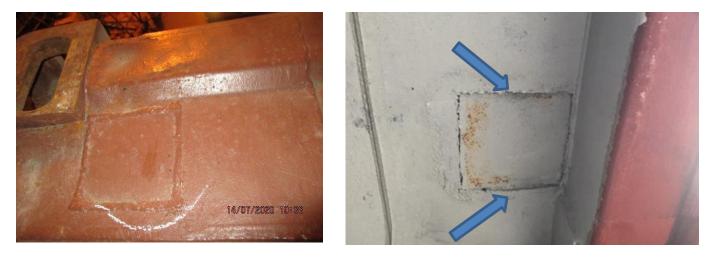
Non-conforming repair: insert installed on the corner protection plate however no insert installed on the extension plate.
