EPIC GLOBAL SERVICES PVT.LTD

Title: Limitations on the Repair of Understructure Components

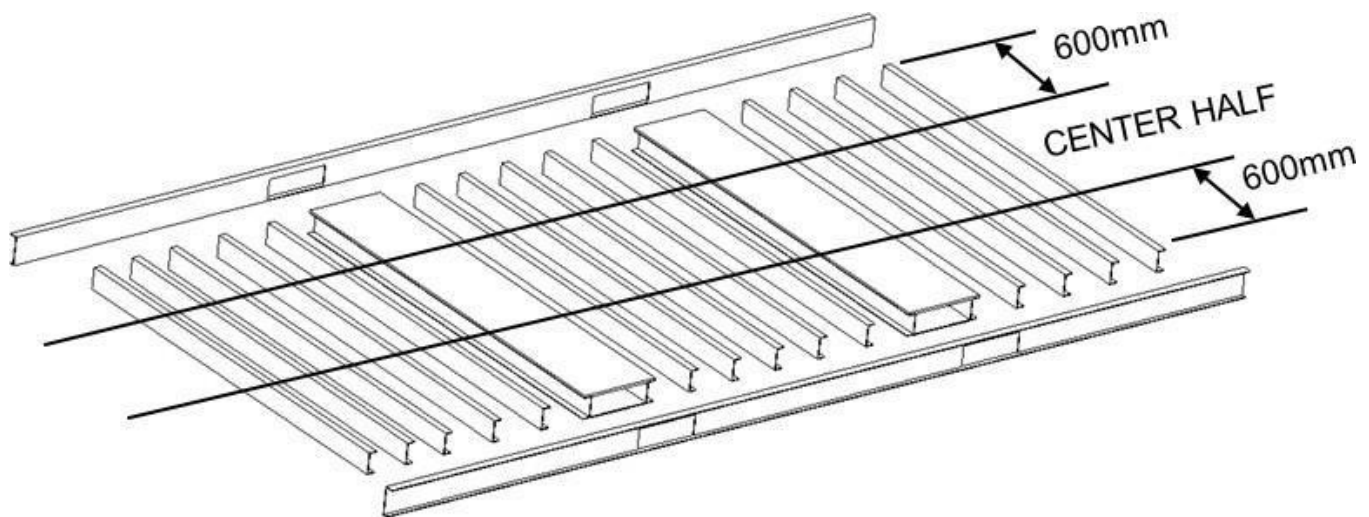
Insert Limitations: Crossmember & Forklift Pocket Side Walls

A correct repair should aim to restore the profile of the damaged component and the surrounding areas as closely as possible to the original configuration. Welding repairs to members (crossmember/forklift pocket side wall) are prohibited within the central half of two adjacent members. The central half of a member is described as the section of the member located more than 600mm from the nearest bottom side rail. If both adjacent members have welding repairs within their central halves, either one of the members must be replaced, or the inserts must be extended to ensure they do not end within the central half of the member.

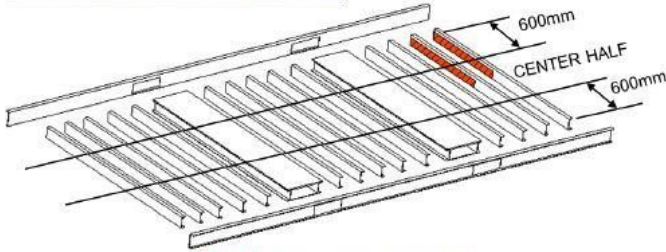
NOT ACCEPTABLE

The insert on the right side is acceptable because it is the 1st crossmember with an insert. But the 2nd insert on the left is not acceptable because the weld seam terminates in the center half of the container.

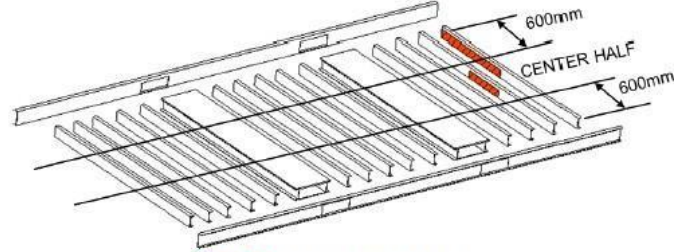
NOT ACCEPTABLE

The insert on the right side is acceptable because it is the 1st crossmember with an insert. The 2nd insert on the left is not acceptable because the weld seams terminate in the center half of the container.

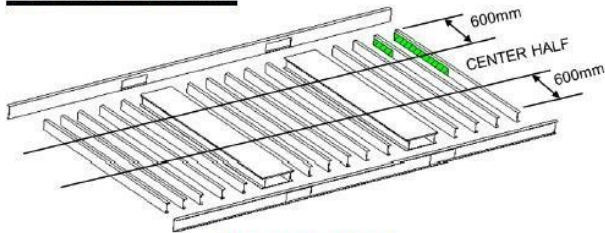
ACCEPTABLE

The insert on the right side is acceptable because it is the 1st crossmember with an insert. The 2nd insert on the left is also acceptable because the weld seams terminate within 600mm from the bottom side rail.

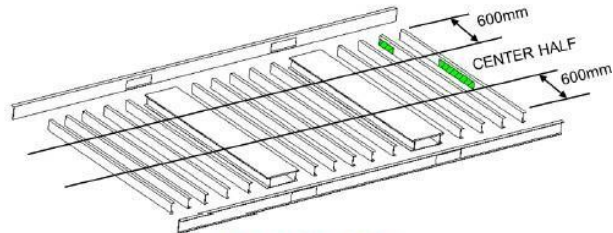
ACCEPTABLE

The insert on the right side is acceptable because it is the 1st crossmember with an insert. The 2nd insert on the left is also acceptable because the weld seams terminate within 600mm from the bottom side rail.

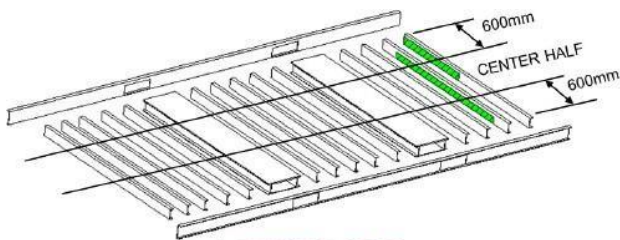
ACCEPTABLE

The insert on the right side is acceptable because it is the 1st crossmember with an insert. The 2nd insert on the left is also acceptable because the weld seams terminate within 600mm from the bottom side rails.

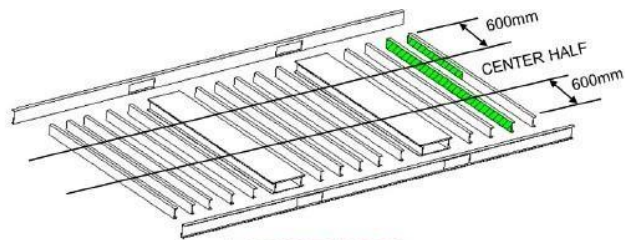
ACCEPTABLE

The insert on the right side is acceptable because it is the 1st crossmember with an insert. The 2nd cross member is also acceptable because it is actually a full replacement.

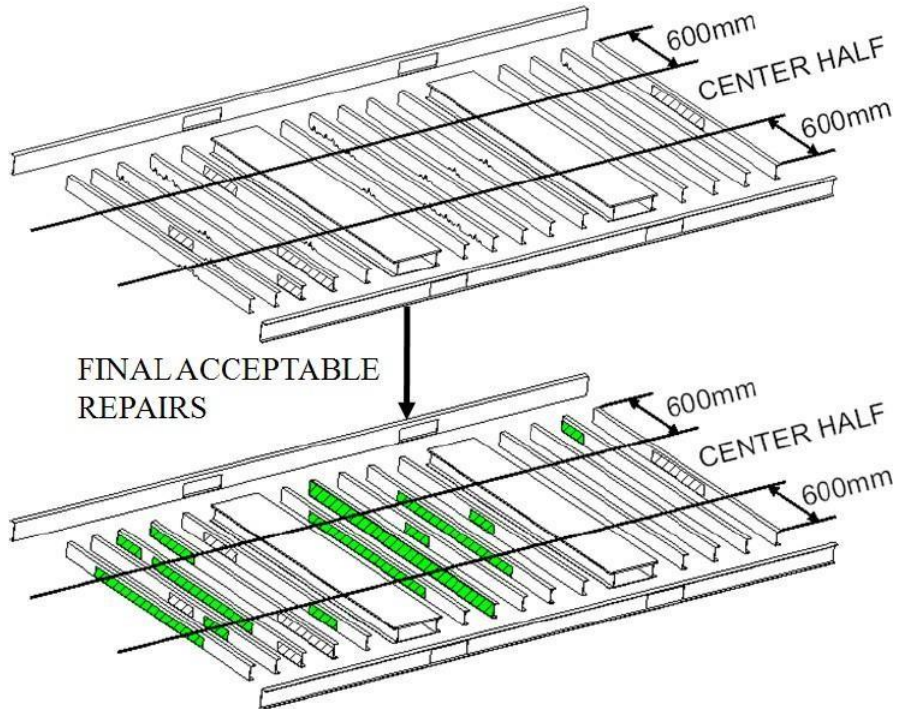
FULL CONTAINER EXAMPLE

AN EXAMPLE of new damage locations and pre-existing inserts.

Approved inserts are determined by considering new damage locations and existing inserts, as depicted above. It is crucial to emphasize that this represents just one instance of a potential combination of damage and acceptable repair inserts. Numerous alternative scenarios may exist. This diagram is intended solely as a reference for identifying the most secure and cost-effective repair approach on a case-by-case basis.

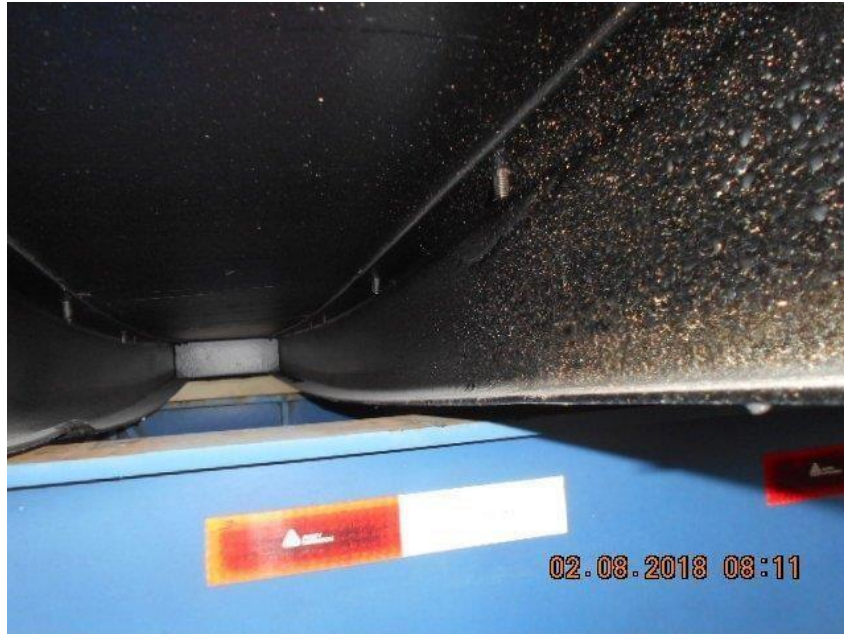
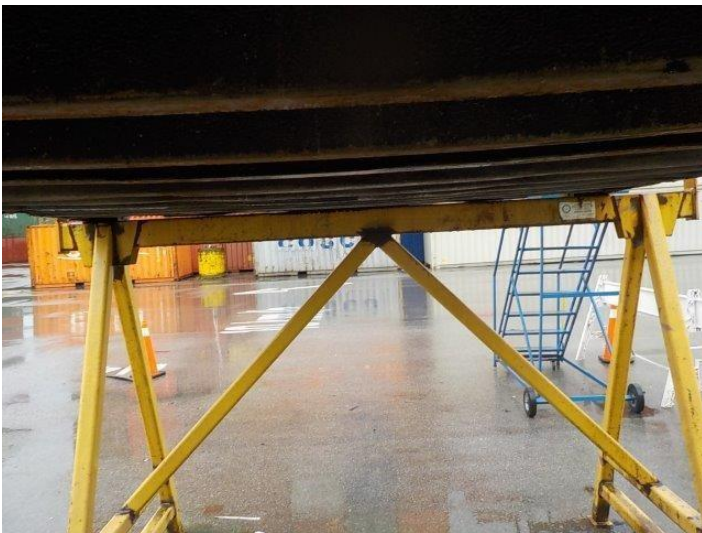
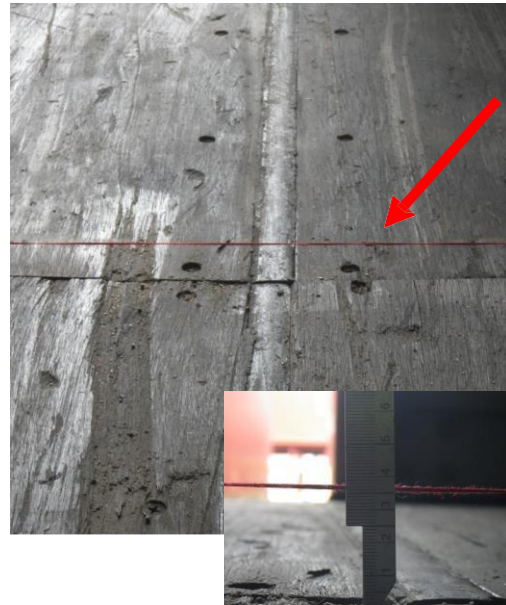
Vertical bowing of understructure components can occur due to various factors such as cargo overloading, improper weight distribution, and impact damage. This issue is exacerbated during typical container lifting operations and at sea, where gravitational forces, including acceleration and deceleration, are at play.

When understructure components, particularly crossmembers, fork pocket components, and occasionally bottom rails, gooseneck tunnel bolster, and rails, experience vertical bowing beyond the IIICL limits, it indicates that they have surpassed their material structural yield point. The yield point signifies the boundary between elastic and plastic behavior in a stress-strain curve. Once the material enters the plastic behavior, characterized by permanent deformations, it cannot be reversed or rectified through heat-based straightening methods. Consequently, the material's strength and its ability to withstand future loads become compromised.

The following photos depict some examples of bowed down understructure components.

For the repair of bowed down understructure components exceeding tolerances, the recommended methods are:

- 1. Full Replacement*
- 2. Insertion within the specified limitations on page 2.*

It's important to note that non-conforming repair methods include cutting relief notches for straightening understructure components or attempting to straighten bowed down understructure components. Conversely, normal alignment work necessary for fitting inserts is considered an acceptable repair method.
